- 6
- A. MECHANICAL PROPERTIES OF ANNEALED
AND MARTENSITIC Ti-6Al-4V. (A.)
 - B. MICROSTRUCTURE OF SOLUTION TREATED
Ti-6Al-4V. (B.)
 - C. A STUDY OF FATIGUE DAMAGE WITH
ULTRASONIC INTERNAL FRICTION
MEASUREMENTS. (C.)
- (use
letter 1)

19 C. M. GILMORE AND M. A. IMAM

NAVAL AIR SYSTEMS COMMAND

MECHANICAL PROPERTIES OF ANNEALED
AND MARTENSITIC Ti-6Al-4V

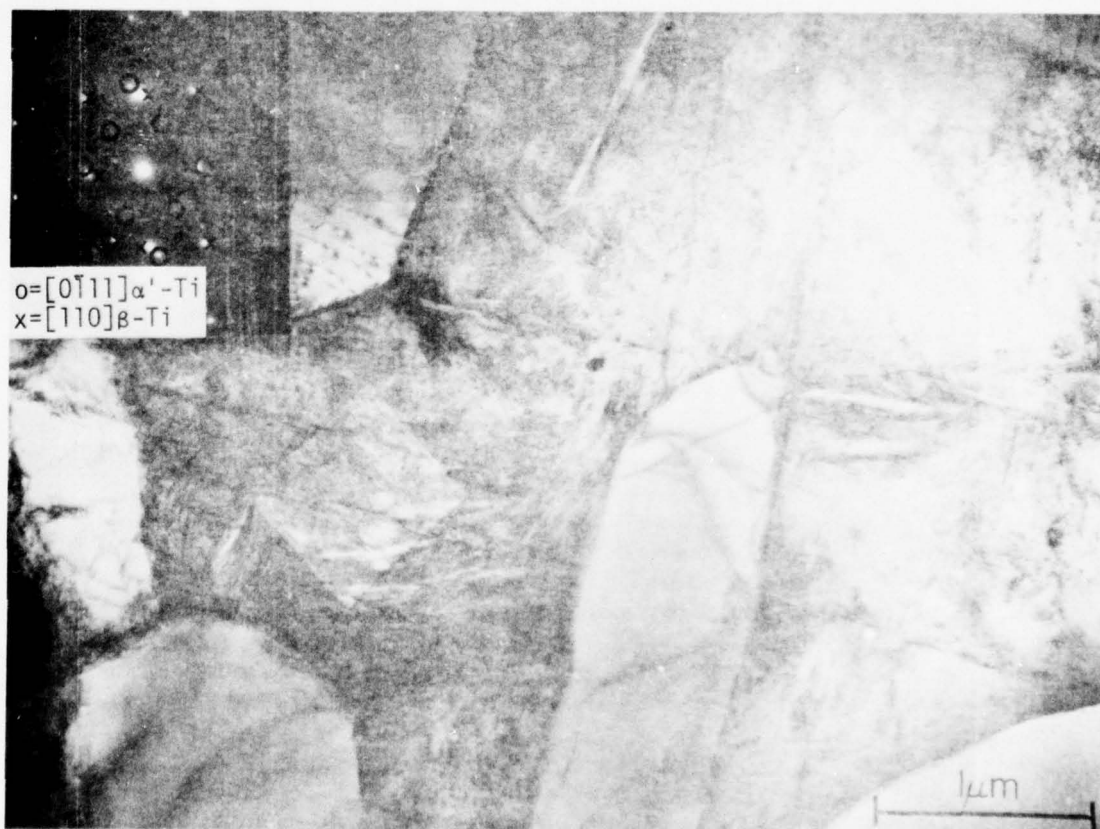
Figure 2 TEM of the alloy solution treated at 900° C. (1650°F.) for 10 min. and water quenched. The diffraction pattern taken from the matrix of the alloy indexes as a mixture of α' (martensite) and retained β . The light areas are primary α .

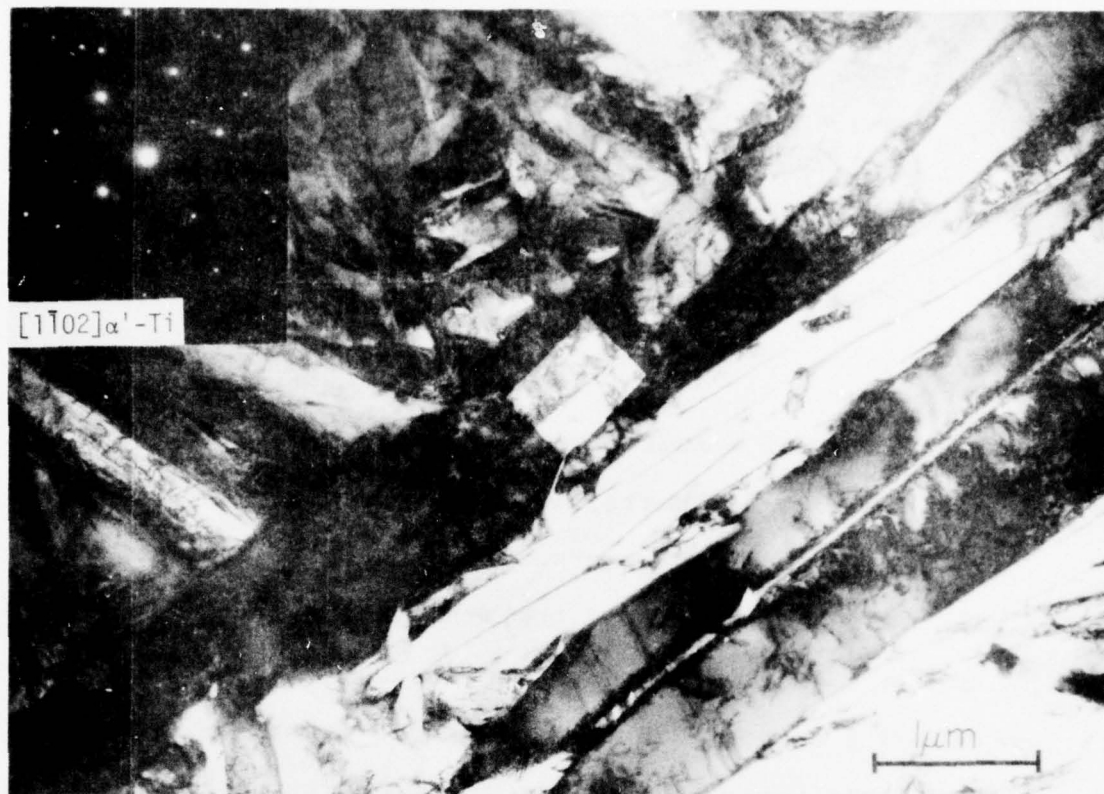
Figure 5 TEM of the alloy solution treated at 1066° C. (1950° F.) for 10 min. and water quenched. The electron diffraction pattern indexes to be α' (hexagonal) martensite.
